Inspection Report

Property Address:
1920 SW 2nd Terrace
Cape Coral FL 33991

MEF Home Inspections LLC

Date: 11/3/2026	**Time:** 10:00 AM	**Report ID:** 20261103-1920-SW-2nd-Terrace
Property: 1920 SW 2nd Terrace Cape Coral FL 33991	**Customer:** Visionary Holdings	**Real Estate Professional:** Katie Martin

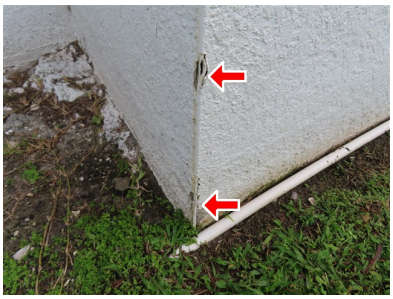
5.4 Item 7 (Picture)
Right side

(2) Minor cracking was visible in stucco covering exterior walls of the home. Cracks exceeding 1/16-inch in width should be filled with an appropriate material to prevent future damage from moisture and monitored in the future for continued activity.

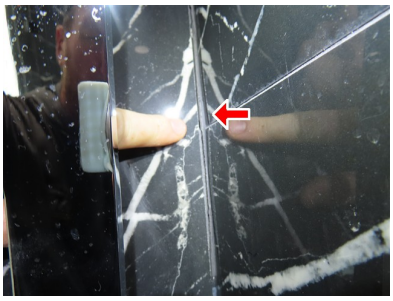
8.6 Item 1 (Picture)

Grout maintenance needed at 1st shared bathroom shower.
